SUBJ: RCRA Compliance Evaluation Inspection
ABC Coke Division, Drummond Company, Inc.
EPA ID# ALD000823179

Enclosed is a copy of the U.S. Environmental Protection Agency inspection report documenting the results of the August 30-31, 2011, inspection of ABC Coke Division, Drummond Company, Inc. located at 900 Huntsville Road in Tarrant, Alabama. This was an EPA Compliance Evaluation Inspection (CEI) for the purpose of evaluating the facility's compliance with the applicable Resource Conservation and Recovery Act (RCRA) regulations.

COMPLIANCE EVALUATION INSPECTION PHOTOGRAPHS

August 30-31, 2011

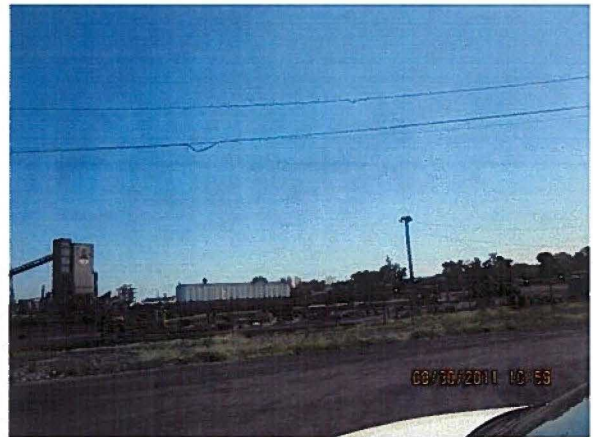
Picture 5 – Incoming material flow from rail and/or truck

Incoming loads of coke, breeze (ground up coke, (Picture 6)) and coal are brought in via rail and truck. The cars are placed on a rotary dump and rolled over to empty the cars. Material Handling is located on the left side of the smoke stack and the Chemical Plant on the right side (Pictures 3-5). The Material Handling area feeds the batteries located along the north and south line of the facility. Ten silos located in the Material Handling area are used to store coal, breeze and non-solid wastes (Picture 7). Banks of coal are stockpiled in the Material Handling area with ditches dug beside them to capture runoff coal in the storm water. Piles of coke are also stored for feeding into the furnaces (Picture 8).

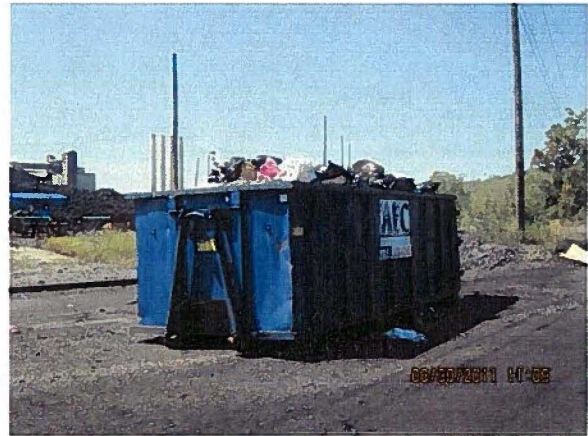
Picture 11 – KMAC Recycling yard – facility trash roll off

KMAC Services (EPA ID ALR000008474) is an independent contractor who collects the waste streams of non-hazardous materials from around the facility. The "trash" waste is collected in blue open roll off and disposed of in a local landfill (Picture 11). KMAC also collects carbon waste generated from around the facility (Pictures 15-16).

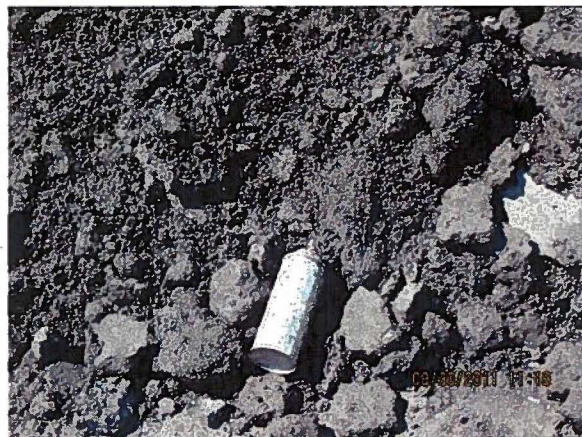
Picture 17 – KMAC yard – Aerosol can in the carbon waste recycling pile

The carbon waste is considered low-specification but still has an output of at least 10,000 BTUs. KMAC removes the carbon from the waste and resells the carbon. KMAC is located at the end of Material Handling by the finished coke stockpiles (Pictures 12-14). At the time of the inspection, the inspection team observed plant trash (i.e., two partial filled aerosol cans) on top of the carbon waste piles (Picture 17). Both cans were missing labels and nozzles.

ABC Coke is in apparent violation of ADEM Administrative Code R. 335-14-2-.01(2) [40 C.F.R. § 262.11]. A person who generates a solid waste, as defined in 335-14-2-.01(2), must determine if that waste is a hazardous waste. The aerosol cans' contents and the carbon from the facility waste needs hazardous waste determinations.

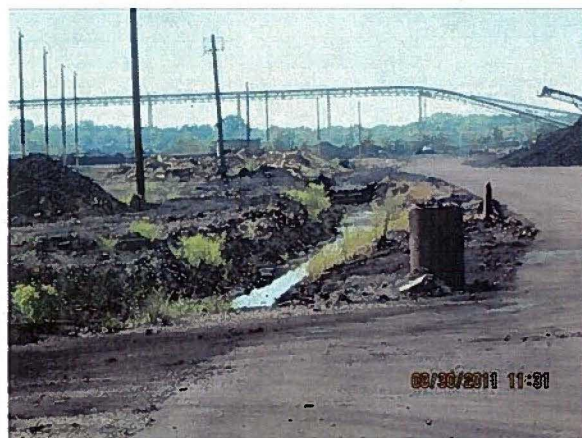
Picture 18 – Storm water run off ditch with a dam

The inspection team observed storm water ditches beside the coke and coal stockpiles (Picture 18). The storm water ditches are used to collect the runoff coal fines. The storm water and fines flow into a Pre-Treatment Pond (Picture 19) where the fines settle out and are removed. The fines are analyzed to determine if they can be possibly used in the process or as base building material for the coke piles. An outlet from the Pre-Treatment Pond releases the storm water into the Surface Impoundment (Pictures 21-22). The storm water from the Pre-Treatment Pond is not tested prior to release to the Surface Impoundment.

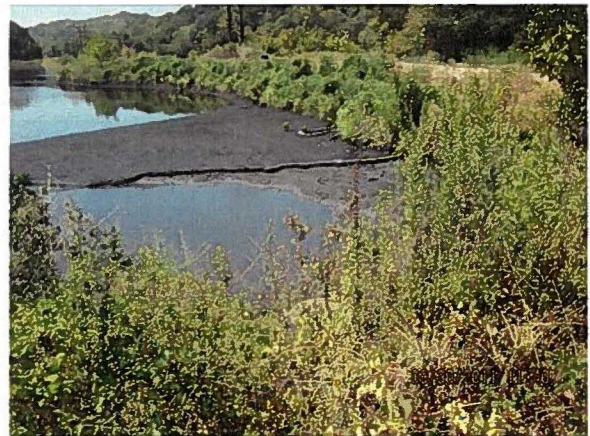
Picture 23 – Inlet to surface impoundment

Directly across from the Pre-Treatment Pond is the Surface Impoundment (Picture 20). An inlet pipe releases the storm water from the Pre-Treatment Pond into the clay-lined Surface Impoundment (Picture 23). Banks of coal fines surround the inlet (Pictures 24-25) at the mouth of the Surface Impoundment.

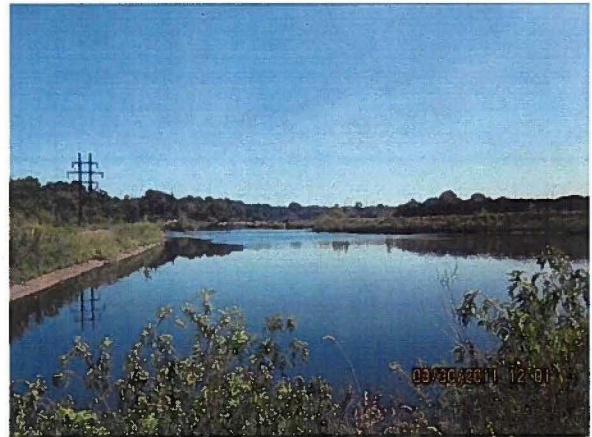
Picture 29 – Long view of Surface impoundment

The Surface Impoundment flows from the inlet, around the fines banks to a filter dam (Picture 27). The storm water permeates the filter dam which is constructed of ½ inch felt under six-inches of sand and twenty feet of riprap. The dam was constructed in 1985, and goes the entire depth of the Surface Impoundment. Beyond the dam is a concrete spillway (Picture 28), and to the right of the dam is the Surface Impoundment extends and borders along the KMAC Area (Pictures 29-30).

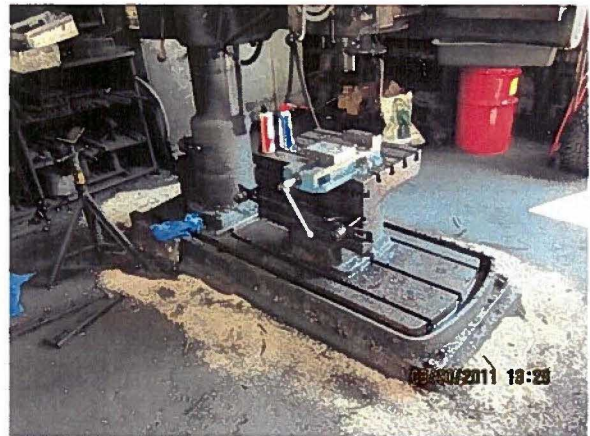
Picture 34 – Main Maintenance Shop absorbent around equipment base

The Main Maintenance Shop has the one of three solvent parts washers supplied by Safety Kleen Systems, Inc. (Picture 33). At the time of the inspection, the inspection team observed absorbent on top of an oily substance surrounding an equipment base (Picture 34) and a KMAC scrap bin with discarded aerosol cans (Pictures 35-36).

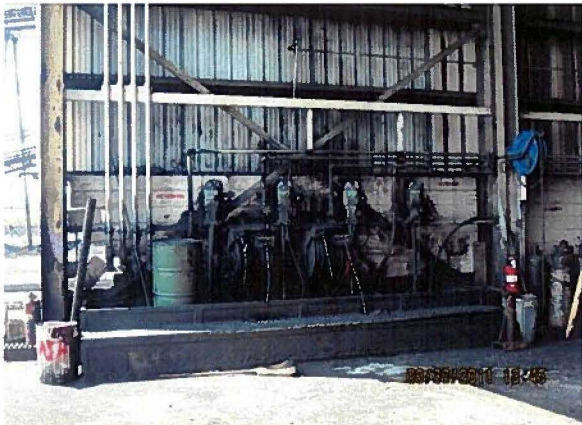
Picture 37 – Container Building oil distribution station

The inspection team observed in the Container Building an oil distribution station (Picture 37), a used oil tank in secondary containment (Pictures 38-39), a green 55-gallon drum marked "Scrap Oil" (Picture 40) a green KMAC scrap bin (Picture 41), a labeled used oil container with a labeled funnel (Picture 42), a blue plastic swimming pool had an oily residual (Picture 43), an open, unlabeled 5-gallon container of used oil residuals (Picture 44), an open 5-gallon container of used oil with two spent oil filters inside (Picture 45), two labeled and open used oil drainage

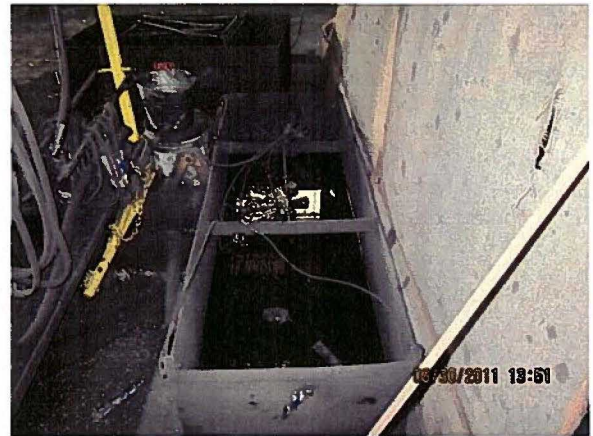
Picture 46 - Container Building open used oil container

ABC Coke is in apparent violation of ADEM Administrative Code R. 335-14-17-.03(4)(a)(1) [40 C.F.R. § 279.22(a)(1)]. A container holding used oil must always be closed during storage, except when it is necessary to add or remove used oil. An open used oil container held two used oil filters inside and the used oil container in Picture 46 had more than one-inch of residual inside.

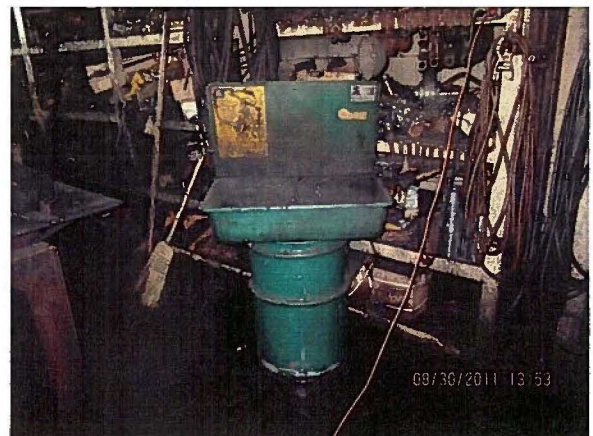
Picture 48 - Container Building parts washer with oil residue around bottom of the drum

ABC Coke is in apparent violation of ADEM Administrative Code R. 335-14-6-.09(2) [40 C.F.R. § 265.171]. If a container holding hazardous waste is not in good condition, or if it begins to leak, the owner or operator must transfer the hazardous waste from this container to a container that is in good condition, or manage the waste in some other way that complies with the requirements of this part. The Safety Kleen parts washer drum had an oily residual around the bottom of the drum and on the surrounding floor.

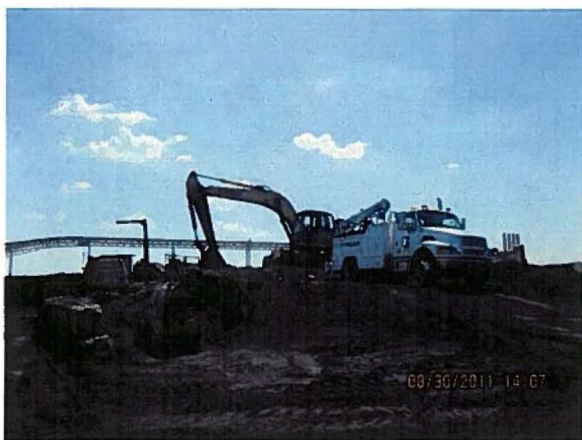
Picture 49 – View of Kipin Process Area

At the time of the inspection, the Kipin Process Area was not in operation. The inspection team observed the entrance (Picture 49-50) to the area clear of heavy equipment but there were by-products in the half-vats (Picture 51-53). Beside the mixing area is a shed where the finished by-products mixture is placed on conveyor and sent to a silo (Picture 54). Near the shed are two metal tanks marked "Holding Tank" (Picture 64). These tanks are used to hold the liquid to be mixed into the process. An overall view of the Kipin Process in Pictures 65, 66 and 69 showed the half-vats filled with coke by-products, the bins where the coal was added and the conveyor system to the concrete pad, as well as the conveyor system to the silo in the background.

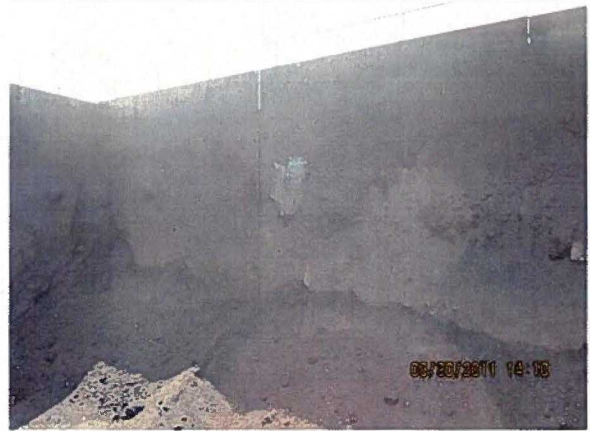
Picture 58 – Kipin Process Area mixture pad steel side wall

The concrete pad in the Kipin process area is surrounded on three sides by walls constructed of concrete blocks and covered in 1/2-inch steel seam welded sheets. The base or floor of the pad is eighteen inches of impermeable concrete with a six-inch channel poured in concrete (Pictures 55-56, 58-60). At the time of the inspection, the inspection observed the seam welded sheets showed gaps and openings at the welds, and the walls had damage from the use of heavy equipment. Coke by-products are considered hazardous waste until recycled. However, at the time of the inspection, the by-products were not sufficiently contained in the Kipin process area because of the gaps in the welded seams..

ABC Coke is in apparent violation of ADEM Administrative Code R. 335-14-6-.03(2) [40 C.F.R. § 265.31]. Facilities must be maintained and operated to minimize the possibility of a fire, explosion, or any unplanned sudden or non-sudden release of hazardous waste or hazardous waste constituents to air, soil, or surface water which could threaten human health or the environment.

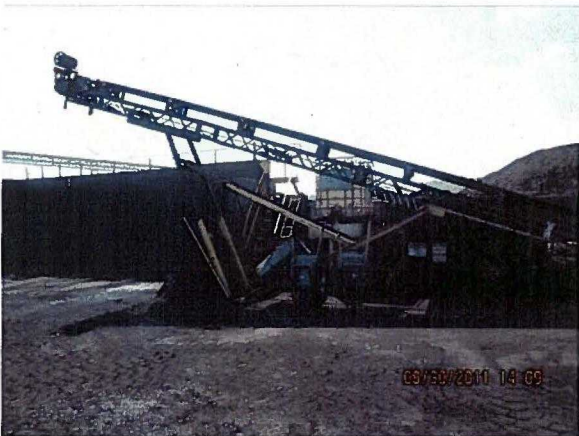
Picture 59 – Kipin Process Area mixture pad steel side wall

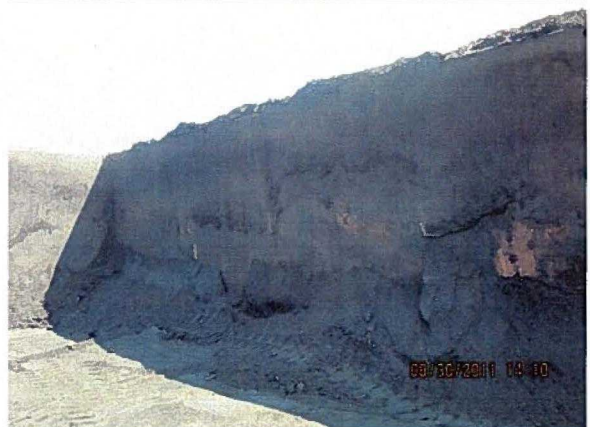
Between the half-vats and the concrete pad were the equipment building (Picture 61) and the conveyor system used to move the by-products mixture on the concrete pad (Picture 57). The inspection team observed discarded materials on the ground next to the equipment building (Picture 62). The inspection team was informed that discarded material would be cleaned and sent to the KMAC area. Near the discarded materials was runoff liquid from the equipment (Picture 63).

Picture 57 – Kipin Process Area mixture conveyor to pad

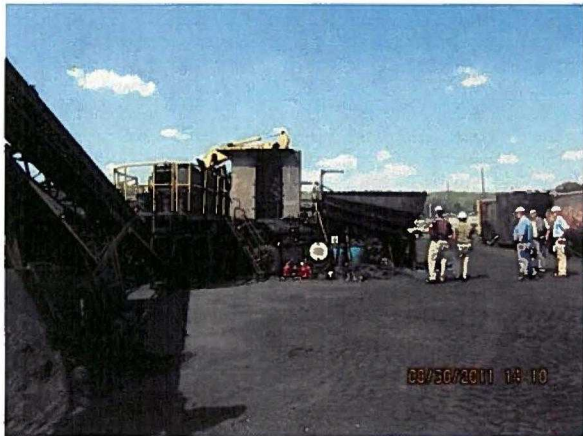
Picture 60 – Kipin Process Area mixture pad steel back wall

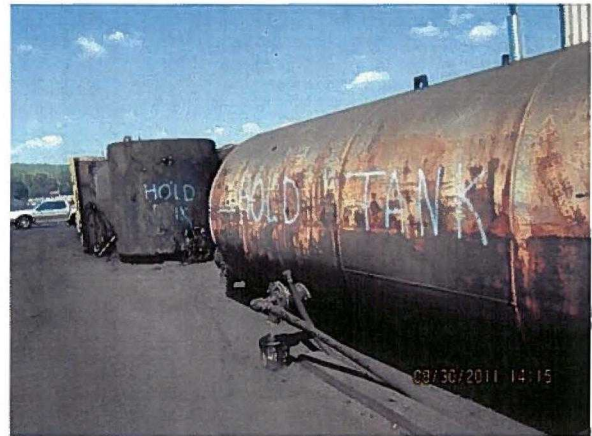
Picture 63 – Kipin Process Area liquid discharge from equipment

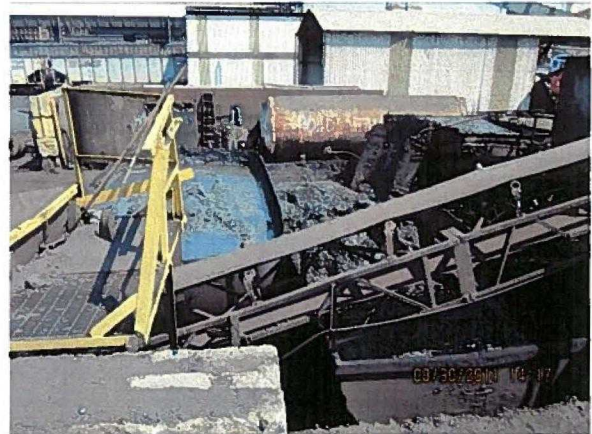
Picture 64 – Kipin Process Area Hold Tanks for liquid used in the process

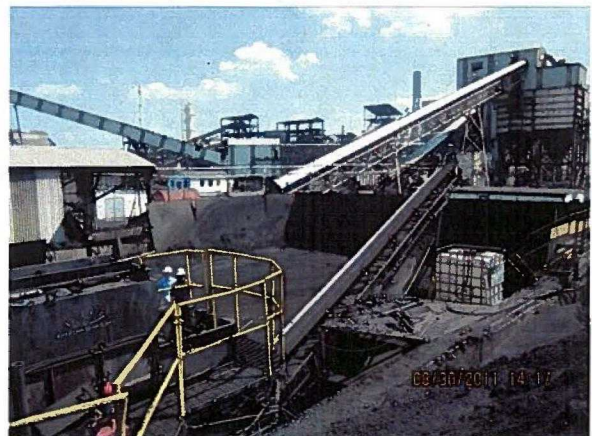
Picture 65 – Kipin Process Area mixing area and conveyor

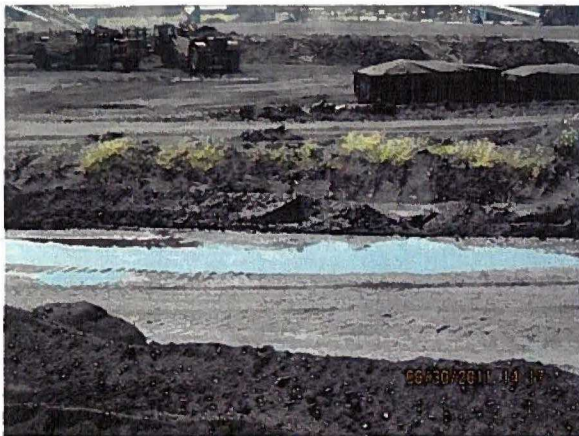
Picture 66 – Kipin Process Area mixing area and conveyor

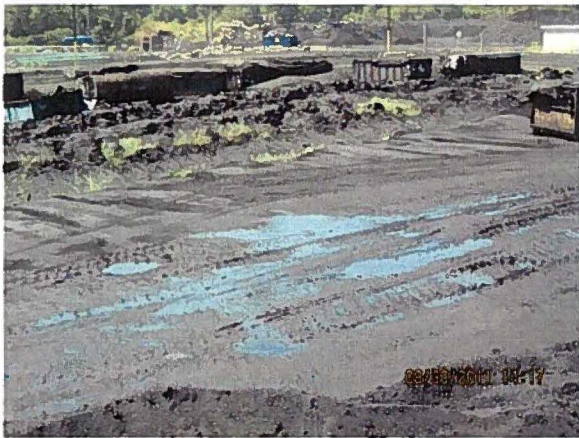
Picture 67 – Sprinkler water run off

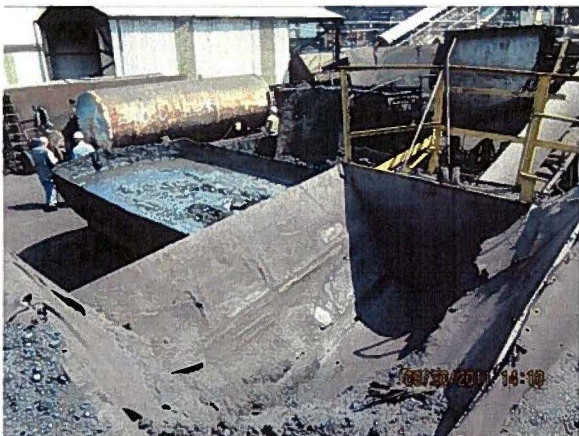
Picture 68 – Sprinkler water run off

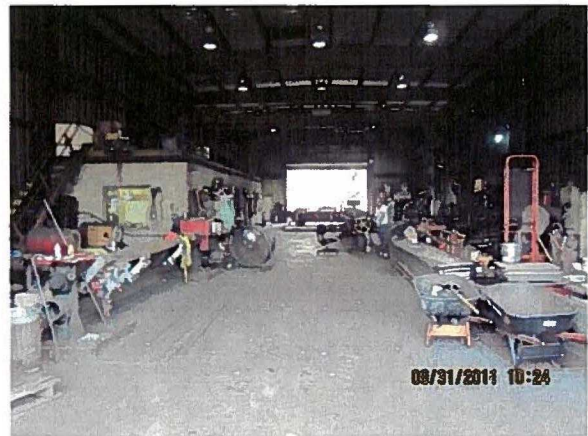
Picture 69 – Above view of Kipin Process Area

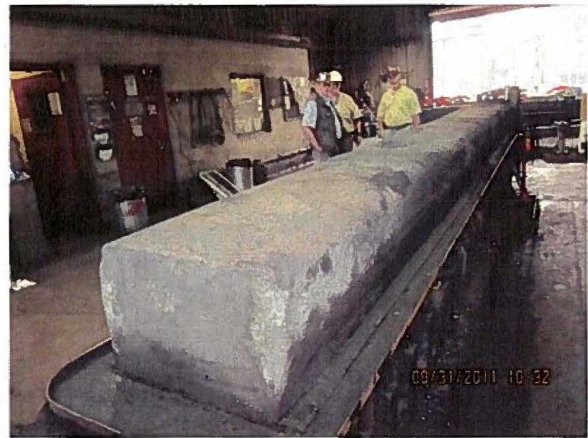
Picture 71 – Door Maintenance Shop door with a ceramic plug

The Door Maintenance Shop removes, repairs and replaces the doors of the furnaces (Picture 70). The doors are fitted with ceramic plugs inside (Picture 71) for heat insulation. The plugs, manufactured in Pittsburgh, PA, are replaced every six months when they become too cracked and then used in the facility as drainage ditch dividers.

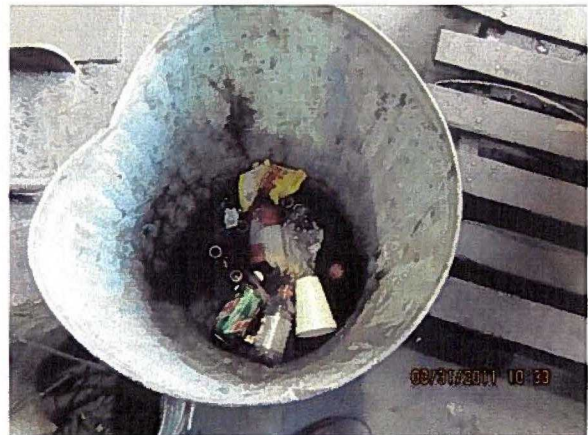
Picture 72 – Door Maintenance Shop garbage can with Kroil aerosol can inside

During the inspection, the inspection team observed cans of Kroil and paint in the shop (Pictures 72) and a can of Kroil in the shop garbage (Picture 73). Kroil is listed in the material safety data sheet as combustible liquid and vapor.

ABC Coke is in apparent violation of ADEM Administrative Code R. 335-14-2-.01(7)(a)(2) [40 C.F.R. § 261.7(a)(2)]. A container that is not empty or an inner liner removed from a container that is not empty, as defined in 335-14-2-.01(7)(b) is subject to regulation under 335-14-2 through 335-14-9 and to the notification requirements of Section 3010 of RCRA.

ABC Coke is in apparent violation of ADEM Administrative Code R. 335-14-2-.01(2) [40 C.F.R. § 262.11]. A person who generates a solid waste, as defined in 335-14-2-.01(2), must determine if that waste is a hazardous waste.

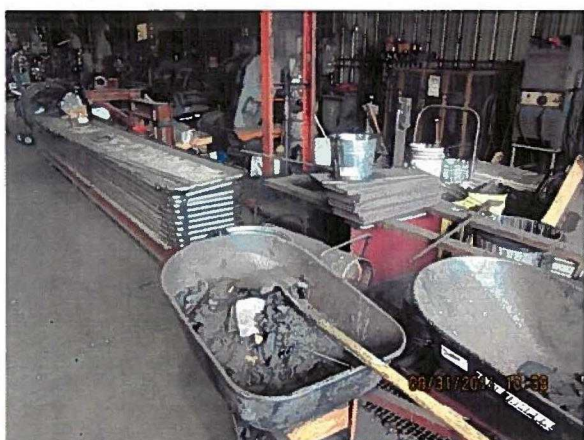
Picture 74 – Door Maintenance Shop carbon from a door to be recycled

At the time of the inspection, the inspectors observed carbon from a door in a wheel barrow (Picture 74). The door removed from repair is covered with carbon from the furnace. The carbon is removed from the door depending on the British Thermal Unit (BTU) value may be recycled thru the Kipin Process. However, if the BTU value is too low then the carbon is recycled through the KMAC yard.

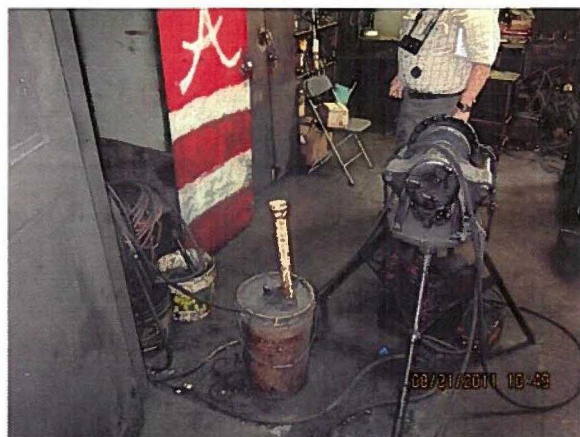
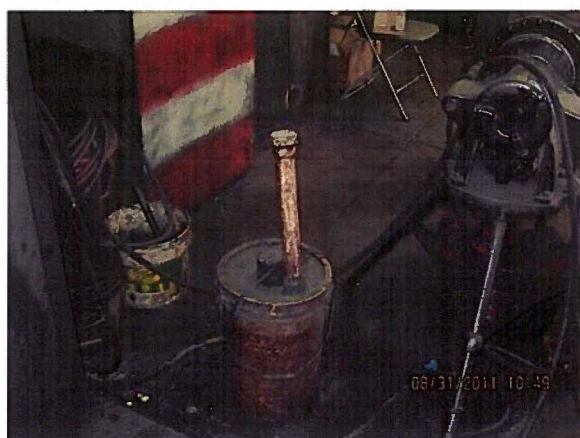
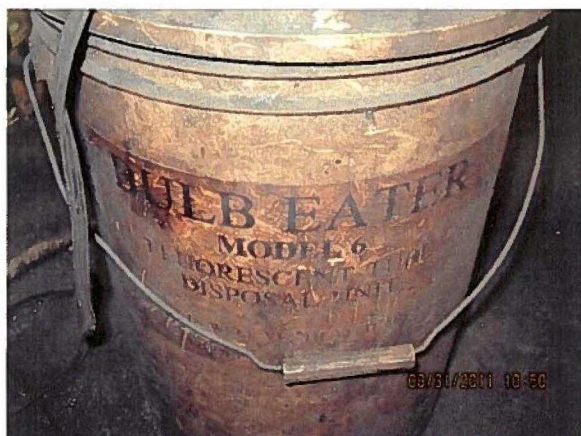
Picture 77 – Electrical Shop bulb crusher

The Electrical Shop collects and replaces the spent fluorescent lamps and HID lamps at the facility (Picture 75). The shop crushes the fluorescent lamps in a non-filtered bulb crusher attached to a 5-gallon container (Picture 77-79). Air Cycle Corporation located in Lisle, IL, manufactured the Bulb Eater® Model No. 6 Fluorescent Tube Disposal Unit. The crushed lamps are bagged in black plastic trash bags and discarded by KMAC. The spent HID lamps are also picked up and discarded by KMAC.

ABC Coke is in apparent violation of ADEM Administrative Code R. 335-14-11-.01(5)(b)(3). Lamps that are broken, crushed, or otherwise no longer intact are not to be handled as universal waste.

ABC Coke is in apparent violation of ADEM Administrative Code R. 335-14-2-.01(2) [40 C.F.R. § 262.11]. A person who generates a solid waste, as defined in 335-14-2-.01(2), must determine if that waste is a hazardous waste. The crushed lamps disposed of by KMAC need to be determined to be hazardous or non-hazardous.

ABC Coke is in apparent violation of ADEM Administrative Code R. 335-14-11-.02(2)(a-b) [40 C.F.R. § 273.11(a-b)]. A small quantity handler of universal waste is prohibited from disposing of universal waste; and prohibited from diluting or treating universal waste, except by responding to releases as provided in 335-14-11-.02(8); or by managing specific wastes as provided in 335-14-11-.02(4) or 335-14-8-.01(1)(c)2.(x).

ABC Coke is in apparent violation of ADEM Administrative Code R. 335-14-11-.02(4)(d)(1) [40 C.F.R. § 273.13(d)(1)]. A small quantity handler of universal waste must contain any lamp in containers or packages that are structurally sound, adequate to prevent breakage, and compatible with the contents of the lamps. Such containers and packages must remain closed and must lack evidence of leakage, spillage, or damage that could cause leakage under reasonably foreseeable conditions.

ABC Coke is in apparent violation of ADEM Administrative Code R. 335-14-11-.02(5)(e) [40 C.F.R. § 273.14(e)]. Each lamp or a container or package in which the lamps are contained must be labeled or marked clearly with any one of the following phrases: "Universal Waste -- Lamp(s)", or "Waste Lamp(s)", or "Used Lamp(s)".

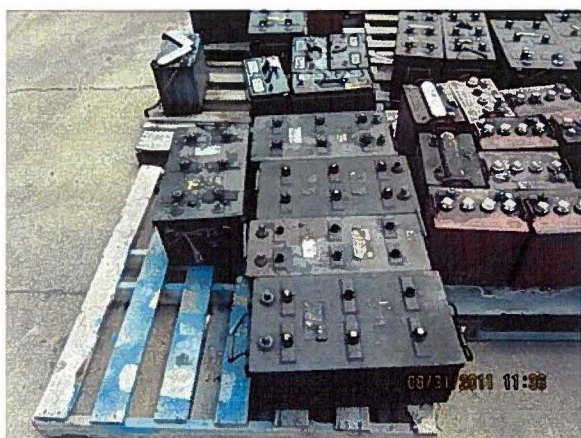
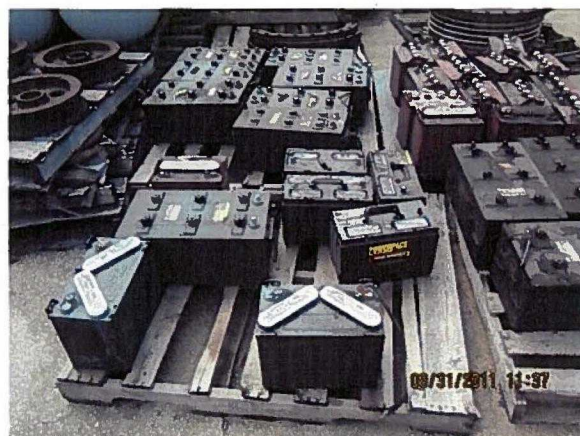
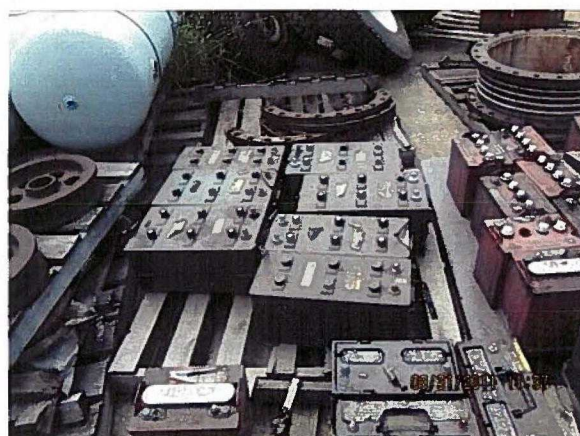
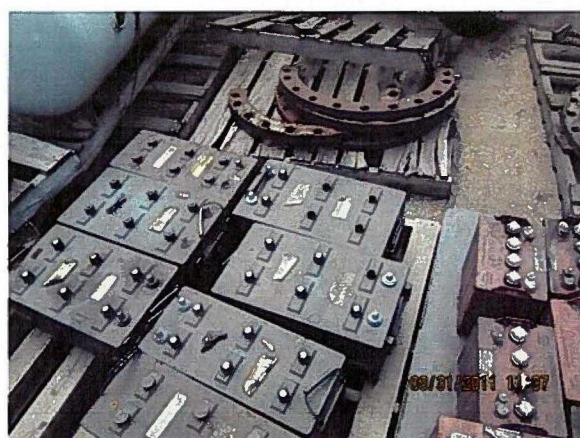
Picture 81 – Storeroom spent lead acid batteries, some with open ports

The Storeroom staff signs and tracks the hazardous waste manifests for the Safety Kleen parts washers. The Storeroom also stores the boxes of new fluorescent lamps and new lead acid batteries. At the time of the inspection, the inspection team observed five pallets of spent lead acid batteries stored outside (Picture 80, 85) waiting to be returned to the supplier. Five of the spent batteries observed had open ports in the battery casing (Picture 81 – 84).

ABC Coke is in apparent violation of ADEM Administrative Code R. 335-14-11-.02(4)(a)(1) [40 C.F.R. § 273.13(a)(1)]. A small quantity handler of universal waste must contain any universal waste battery that shows evidence of leakage, spillage, or damage that could cause leakage under reasonably foreseeable conditions in a container. The container must be closed, structurally sound, compatible with the contents of the battery, and must lack evidence of leakage, spillage, or damage that could cause leakage under reasonably foreseeable conditions.

ABC Coke is in apparent violation of ADEM Administrative Code R. 335-14-11-.02(5)(a) [40 C.F.R. § 273.14(a)]. Universal waste batteries (i.e., each battery), or a container in which the batteries are contained, must be labeled or marked clearly with any one of the following phrases: “Universal Waste-Battery(ies)”, or “Waste Battery(ies)”, or “Used Battery(ies)”.

ABC Coke is in apparent violation of ADEM Administrative Code R. 335-14-11-.02(7) [40 C.F.R. § 273.16]. A small quantity handler of universal waste must inform all employees who handle or have responsibility for managing universal waste. The information must describe proper handling and emergency procedures appropriate to the type(s) of universal waste handled at the facility.

ABC Coke is in apparent violation of ADEM Administrative Code R. 335-14-11-.02(2)(a)(2) [40 C.F.R. § 273.2(a)(2)]. Spent lead-acid batteries which are not managed under 335-14-7-.07 are subject to management under this 335-14-11.

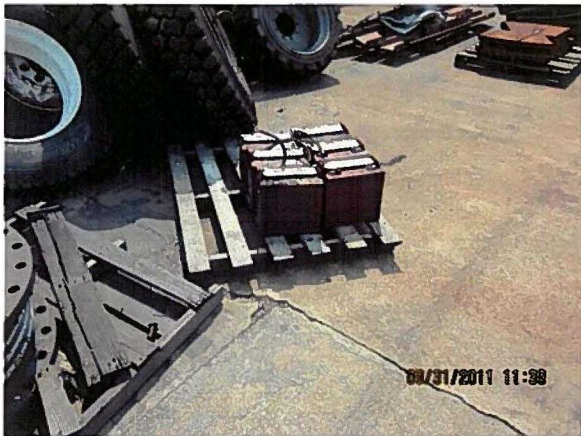
Picture 84 – Storeroom spent lead acid batteries, some with open ports
